# Manhole Inspection Summary

Manhole # S43K\_\_036MH

Insp Date: **6/4/08 9:10 AM**

**Location** Address: **1501 eastern ave**

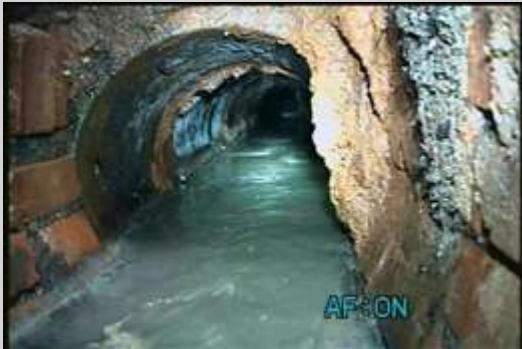
12 O'Clock Outflow

12 in. Circular Gravity Sewer  
Pipe Out @ 12 O'Clock

Pipe Material: **Clay** ☐ Pipe Lined

Deposits: ☒ None ☐ Mud ☐ Sludge ☐ Debris ☐ Grease

Infiltration: **None** Pipe Seal Cond: **Unknown**

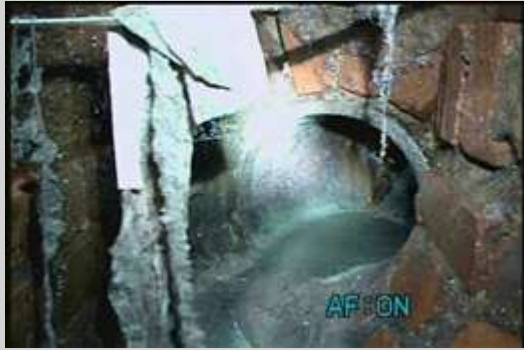
9 O'Clock Inflow

8 in. Circular Gravity Sewer

Pipe In @ 9 O'Clock

Pipe Material: **Clay** ☐ Pipe Lined

Infiltration: **None** Pipe Seal Cond: **Unknown**
